# Marine Corrosion Studies

# The Corrosion Characteristics and Response to Cathodic Protection of Copper Alloys in Quiescent Seawater

(Eighth Interim Report of Progress)

R. E. GROOVER, T. J. LENNOX, JR. AND M. H. PETERSON

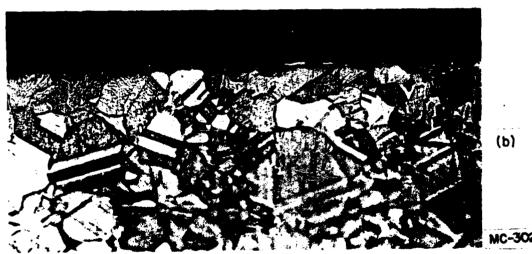
A small amount of dealloying was observed on CDA alloys 230, 443, 608, 612, and 614. These alloys possibly could be used

Fig. 16 - CDA alloy 612 (sluminum bronze, 9%A1). Sampled at crevice opening; 735 days in quiescent seawater at Key West, Florida. Etched (NH<sub>4</sub>OH-5 parts, H<sub>2</sub>O-5 parts, 3%H<sub>2</sub>O<sub>2</sub>-2 parts, 30 seconds). a) 75X magnification; b) 500X magnification.

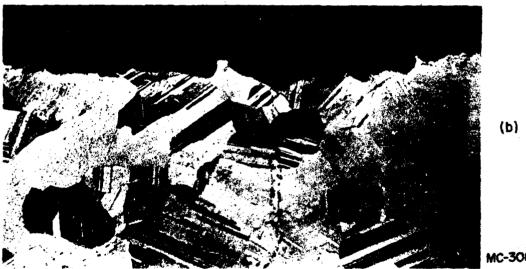
The corrosion rate was highest for the high silicon bronze A (CDA alloy 655), but the depth of localized corrosion was considerably less for this alloy than for alloys such as CDA alloys 260 and 268 which showed corrosion rates of less than one-third the rate observed for alloy 655. This once again points out the fallacy in assessing the usefulness of an alloy soley on the basis of average corrosion rate.

Fig. 19 - CDA alloy 655 (high silicon bronze A). Sampled outside crevice; 735 days in quiescent seawater at Key West, Florida. Etched ( $K_2Cr_2O_7$ -2 g,  $H_2SO_4$ -8 m1, NaC1 saturated solution-4 m1,  $H_2O$ -100 m1; all diluted with 2 vol  $H_2O$ , 10 seconds). a) 75X magnification; b) 500X magnification.
